Manhole Inspection Summary

Manhole # S21MM_014MH

Insp Date: **7/2/07 11:43 AM**

Location Address: **2552 CLIFTON AVE**

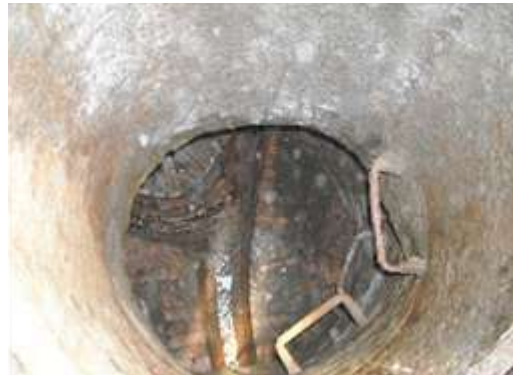
Top View

Comments **TOOK NEW TOP VIEW PHOTO AS REQUESTED - REWORK COMPLETE 3-5-09**

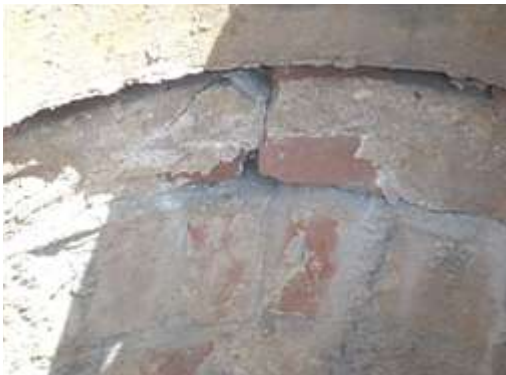
Defect 2

Condition: ☐ Sound ☒ **Cracked** ☐ Root Intrusion ☐ Loose Brick ☐ Deteriorated

CRACKED CHIMNEY

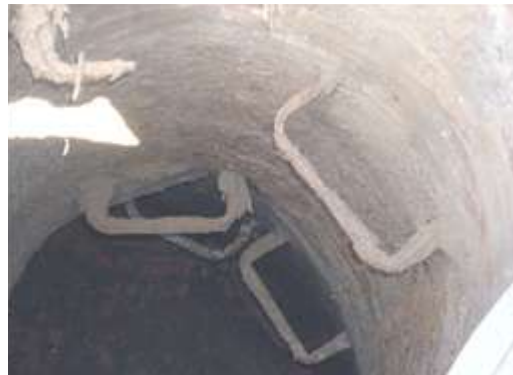
Defect 1

Count: **5** Missing: **1** ☒ **Corroded**

MISSING AND CORRODED STEPS

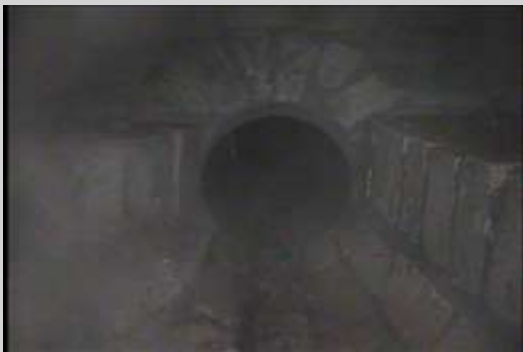
12 O'Clock Outflow

8 in. Circular Gravity Sewer
Pipe Out @ 12 O'Clock

Pipe Height: **8.4** (in.) Rod and Bar (Angled)
Pipe Material: **Clay** ☐ Pipe Lined
Invert Depth: **11.06** (ft.) Flow Characteristics: **Slow**
Deposits: ☒ None ☐ Mud ☐ Sludge ☐ Debris ☐ Grease
Silt Depth: (in.) Deposits Extent:
Infiltration: **None** Pipe Seal Cond: **Sound**

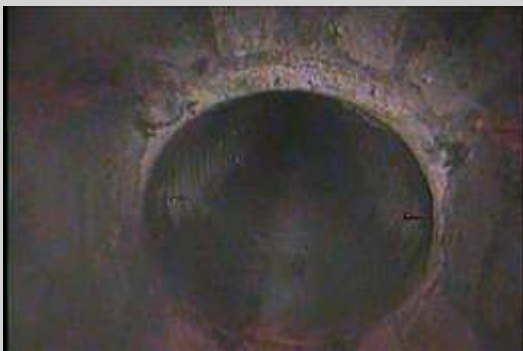
5 O'Clock Inflow

8 in. Circular Gravity Sewer
Pipe In @ 5 O'Clock

Pipe Height: **8.4** (in.) Rod and Bar (Angled)
Pipe Material: **Clay** ☐ Pipe Lined
Invert Depth: **10.62** (ft.) Flow Characteristics: **Slow**
Deposits: ☒ None ☐ Mud ☐ Sludge ☐ Debris ☐ Grease
Silt Depth: (in.) Deposits Extent:
Infiltration: **None** Pipe Seal Cond: **Sound**

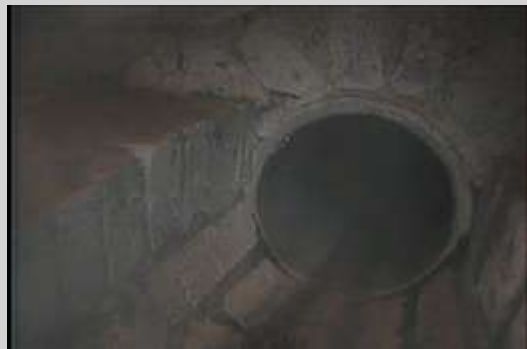
9 O'Clock Inflow

8 in. Circular Gravity Sewer

Pipe In @ 9 O'Clock

Infiltration: **None** Pipe Seal Cond: **Sound**
